Intel[®] Pentium[®] II Xeon[™] Processor Specification Update

Release Date: August 2000

Order Number: 243776-023

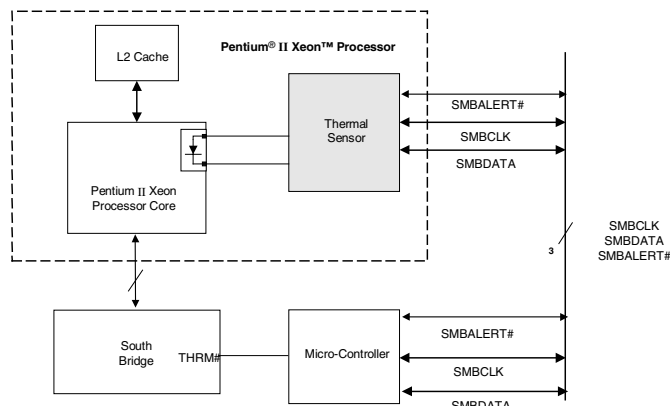
Figure 1. An Example of Microcontroller Driven Thermal Management

D30. Thermal Sensor May Assert SMBALERT# Incorrectly

Problem: The Pentium II Xeon processor has a thermal sensor that monitors the processor core's temperature. The thermal sensor asserts SMBALERT# if the processor temperature exceeds the temperature limits set in the Alarm Threshold Registers (T_{HIGH} , T_{LOW}). It also sets the corresponding Status Register bits to identify the cause of the interrupt. Figure 1 gives one example of how the SMBALERT# signal could be used in a system.
